TAYLOR POND DAM

PHASE I INSPECTION REPORT

NATIONAL DAM INSPECTION PROGRAM

Taylor Pond Dam - ID # PA 00315 Pennsylvania Pike and Monroe Counties Taylor Latitude 41<sup>0</sup> 14.5', Longitude 75<sup>0</sup> 20.2' December 5, 1978

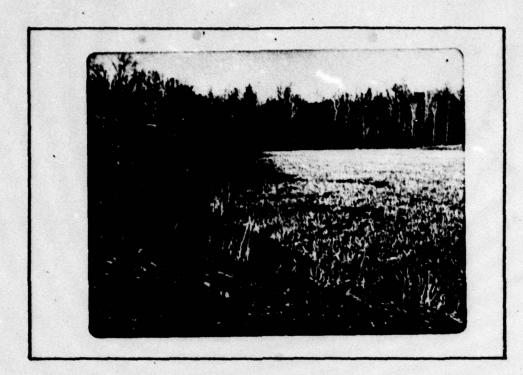
The Emergency Spillway also appears to be in good condition. The grass cover is adequate and the slopes show no signs of instability. The earth dike which separates the embankment from the earth and rock cut

EMERGENCY SPILLWAY LOOKING DOWNSTREAM
